Safety of Rodney House Roundabout

This report has been prepared by Paul Davis, Chair, Graven Hill Residents' Association (GHRA), and a resident of Graven Hill for six years.

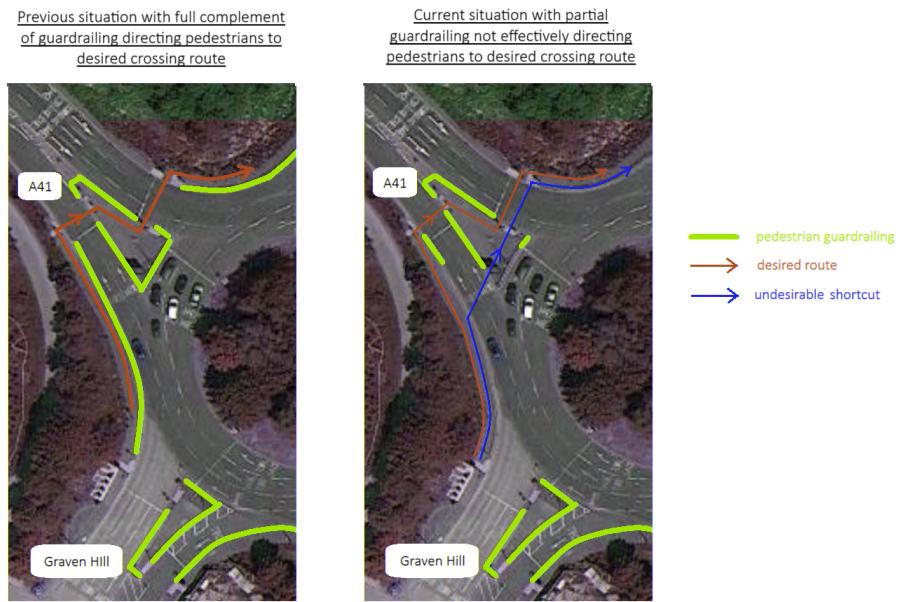
The main purpose of pedestrian guardrailing is to direct pedestrians to the appropriate crossing point [Department of Transport, *LTN 2/09 Pedestrian Guardrailing* (April 2009), section 1.3.5, p.5, <https://assets.publishing.service.gov.uk/media/6116584a8fa8f53dc5ce0f76/ltn-209-pedestrian-guardrailing.pdf>]. A substantial portion of guardrailing at the roundabout was recently removed. This is highly problematic as impatient pedestrians seeking a shortcut can now cross much closer to the roundabout. In doing so, pedestrians will have less visibility of (speeding) vehicles coming around the roundabout, and

those drivers have less visibility of pedestrians crossing in an unexpected place. The fact that the guardrailings removed had been frequently mangled by vehicles losing control amplifies the significance of this point.

This is the case now for crossings on the East and West exits of the A41. The diagrams above show before and after views of the pedestrian crossing on the west exit of the A41. In the left image, the guardrailings used to guide pedestrians to the crossing about 20m away from the junction. The image on the right shows that because of the switchback on the central island to the second part of the crossing, the removal of guardrailings now provides a clear shortcut and desire path.

It is not obvious why the guardrailings were not replaced or alternatively, why other mitigating measures, such as a reduction in speed limit, not applied [DoT, 2.1.8. p.8]. It is true that studies have shown that the removal of guardrailings can lead to less accidents [DoT, 3.3.2, p.14] [Street Behaviour, Collisions Before And After Removal of Pedestrian Railings (July 2017), <https://content.tfl.gov.uk/pedestrian-railings-removal-report.pdf>].

However, results were very site specific, and not deemed significant for roundabouts, whilst also showing guardrailings at roundabouts were very effective at directing pedestrians to the correct crossing points [DoT, 3.3.4, p.14/15]. It is also indicated that the criteria for the removal of guardrailings should be based on how effective it is in directing pedestrians to the appropriate crossing point and so its removal at Graven Hill appears to be contrary to this guidance [DoT, 6.6.2, p.22]. Furthermore, it may be reasonably assumed that even when mangled, they were performing its intended role.

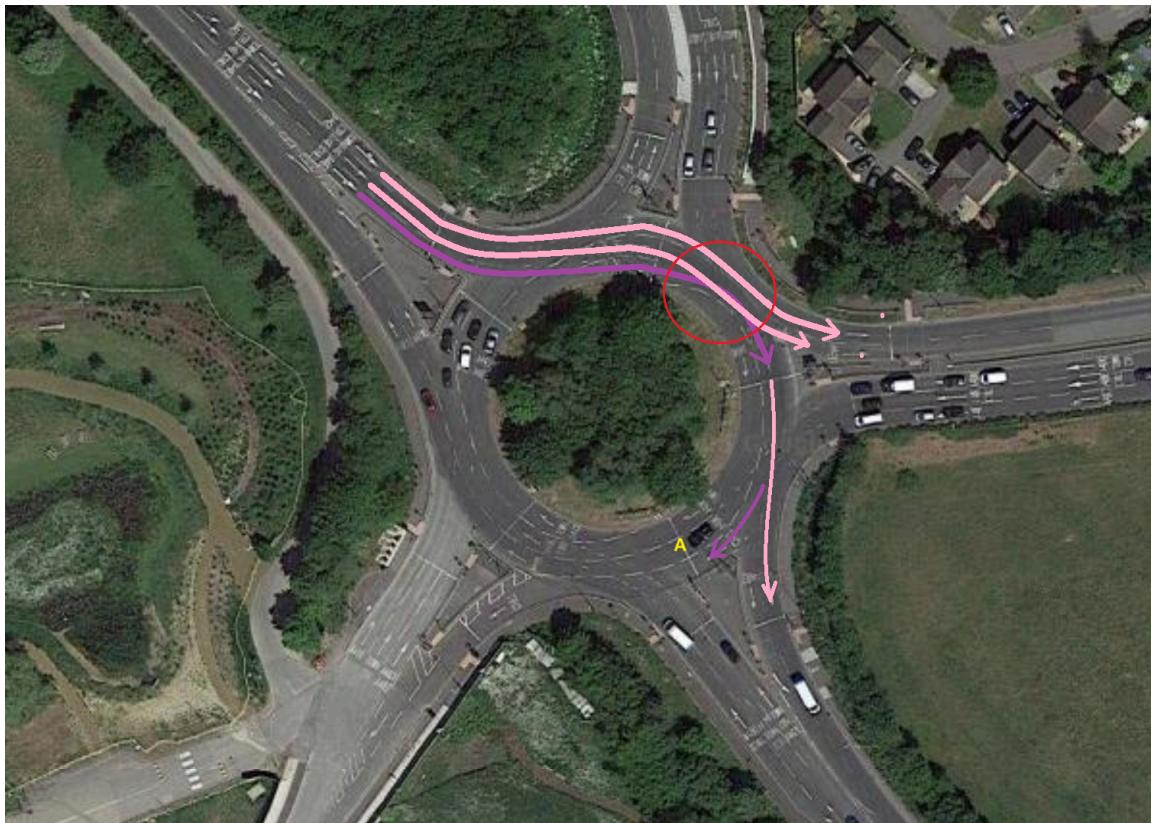
When entering the roundabout on the A41 from the west, traffic to Graven Hill needs to merge with traffic from the lane to the left staying on the A41 and heading east. This requires an unnatural change in line such that it looks like you are swerving into the natural line of the vehicle on your left. This is very problematic and causes a lot of confusion, some shunts and many near misses.

In the above diagram, consider a vehicle approaching from Oxford on the A41 (upper left) and travelling to Graven Hill. They stop at the roundabout in the right-hand lane. To their immediate left is a car travelling onwards to Aylesbury. Both cars are directed to merge into a single lane whilst on the roundabout, as shown by the red circle. The car travelling to Graven Hill (purple line) is explicitly directed away from the lane hugging the roundabout. So, for example, the car marked with an A in the diagram is not travelling to Graven Hill.

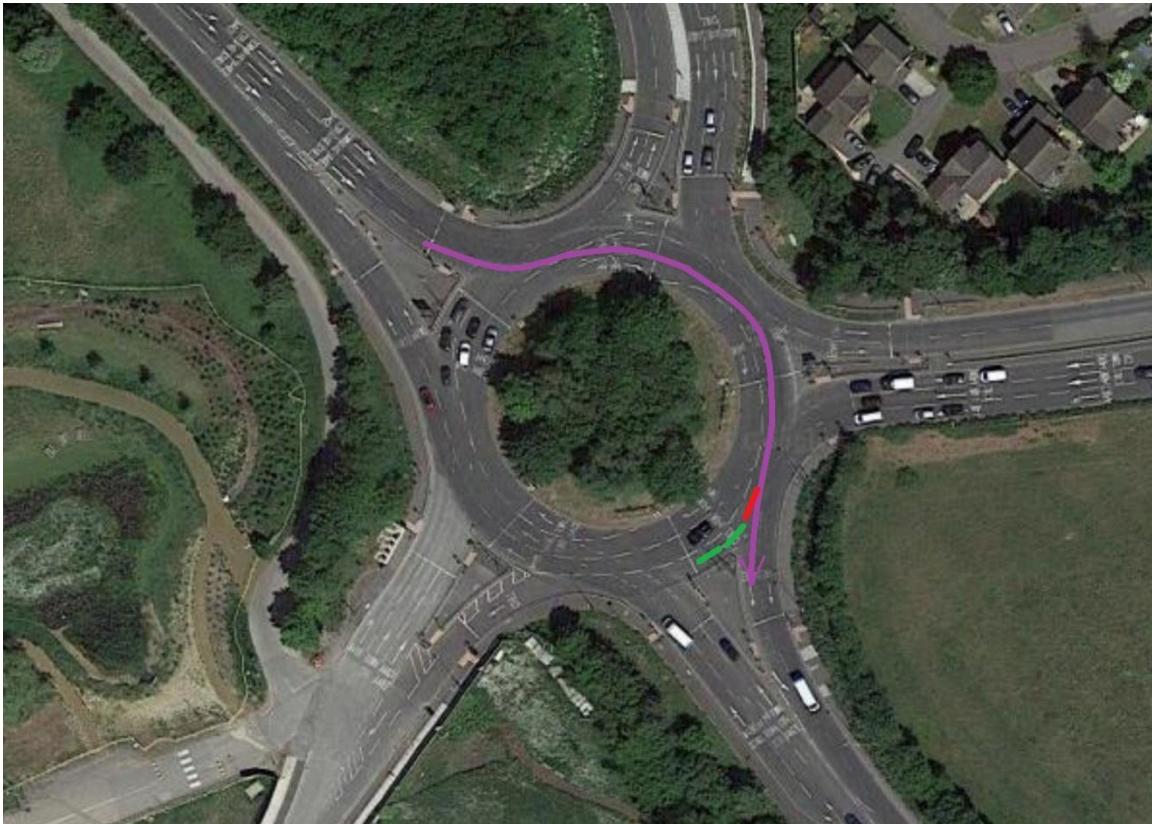
When on the roundabout and waiting at the last set of traffic lights before entering Graven Hill, there is only room for two cars. A third car will overhang the roundabout exit heading east on the A41 and is vulnerable to being hit by vehicles either not paying attention or

speeding. This has been the cause of a number of accidents and near misses (dashcam footage on one such accident is available on request).

In the image above, there is a car waiting at the set of traffic lights on the roundabout immediately before traffic coming from the Aylesbury direction on the A41. As mentioned previously, this car is not travelling to Graven Hill as the lane markings indicate traffic for the A41 and London Road. A car travelling to Graven Hill stops alongside them to their left. If a few vehicles, also heading for Graven Hill, are waiting then the third (as indicated in red) overhangs the roundabout exit for the A41 to Aylesbury. The situation is compounded if the first vehicle is larger than a car, then there only needs to be two vehicles travelling to Graven Hill for there to be a potential problem. It is also particularly the case for traffic that has entered the roundabout on the far-right lane and continuing east on the A41 (as shown by the purple line).

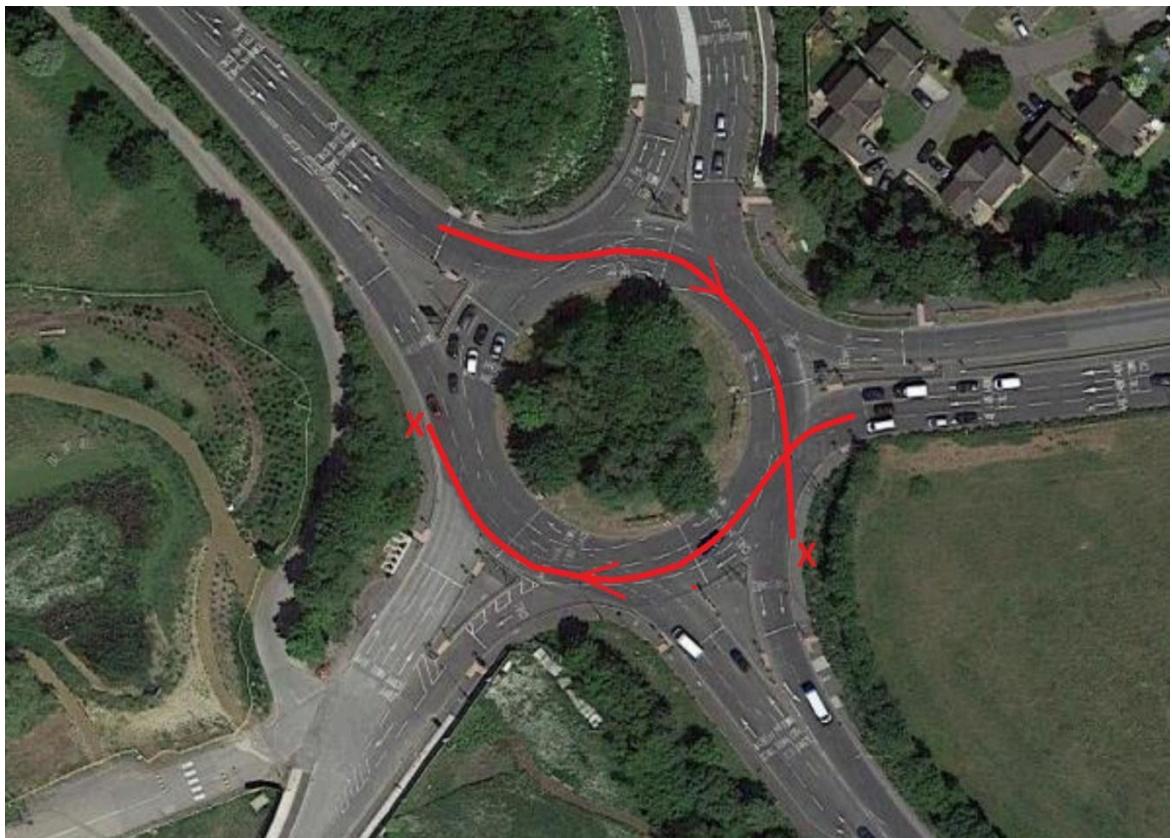
Many vehicles negotiate the roundabout too quickly and lose control on exit. This is particularly so for the two A41 exits, as evidenced by the frequent damage to guardrailings on these exits by the crossings.

The following diagram shows the two key problem points (marked "X"), although mishaps have happened with guardrailing elsewhere on the

roundabout too. The corresponding paths for those vehicles that run into trouble are indicated in red on the diagram and are consistent with where a vehicle might lose control if driving too fast.
