# 2025 accident examples at the Rodney House Roundabout

This document has been prepared by Paul Davis, Chair of the Graven Hill Residents' Association, following the visit of Oxfordshire County Council officers in the Place Planning North team on the 16th December 2025.

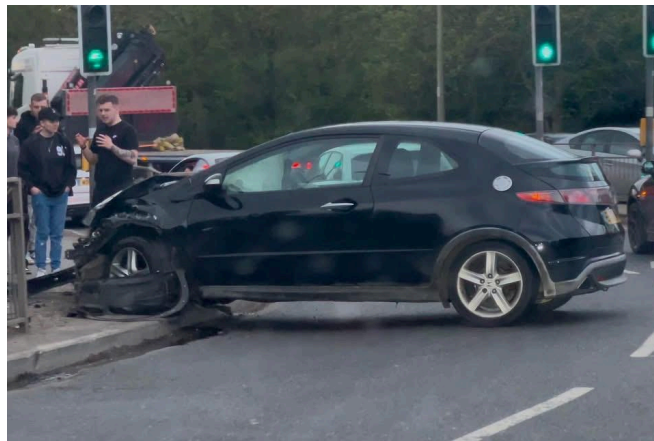
## 1) An accident on the A41 eastern exit towards Aylesbury

The first four accidents shown on the Rodney House roundabout at Graven Hill were likely caused by cars driving too fast on the roundabout and misjudging the exit as a result.

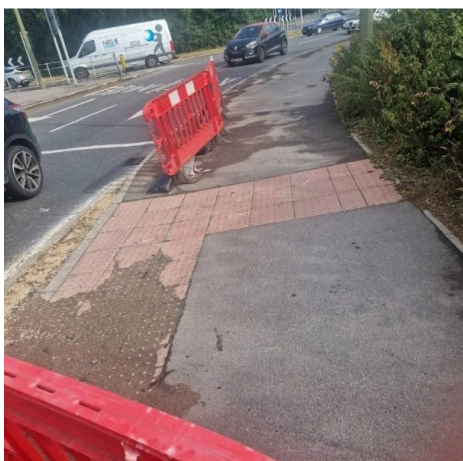
2) Another accident on the A41 eastern exit towards Aylesbury. Here, the traffic lights at the pedestrian crossing have been taken out. This is the set of traffic lights shown on the LHS of the above photo.

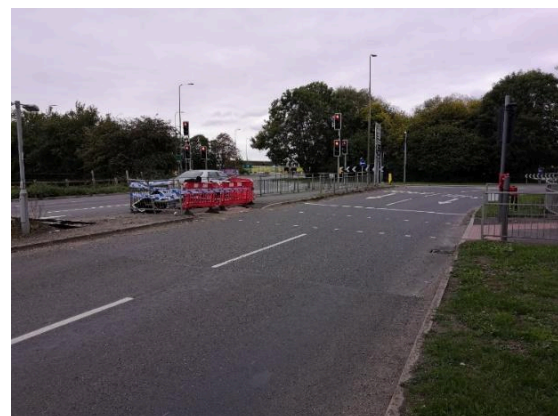
3) For good measure, the other two sets of traffic lights at the same pedestrian crossing were taken out by yet another accident on the eastern exit of the A41 towards Aylesbury. These are the two sets on the RHS of the above photo

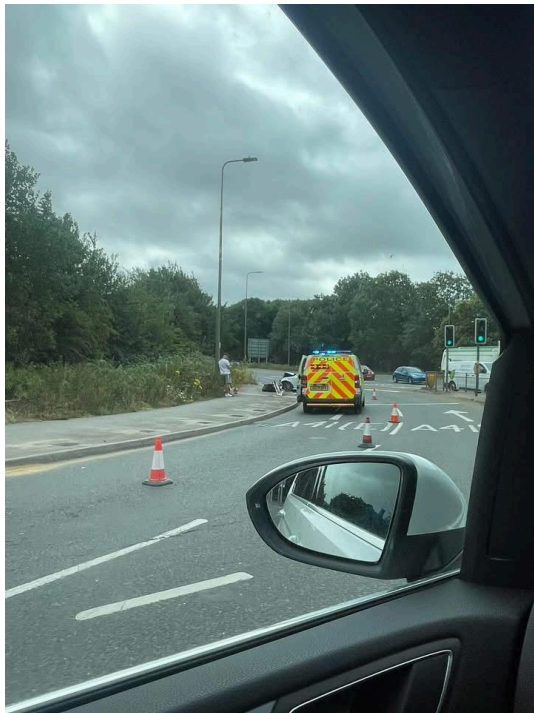
4) The following is one more example of an accident on the A41 eastern exit towards Aylesbury.

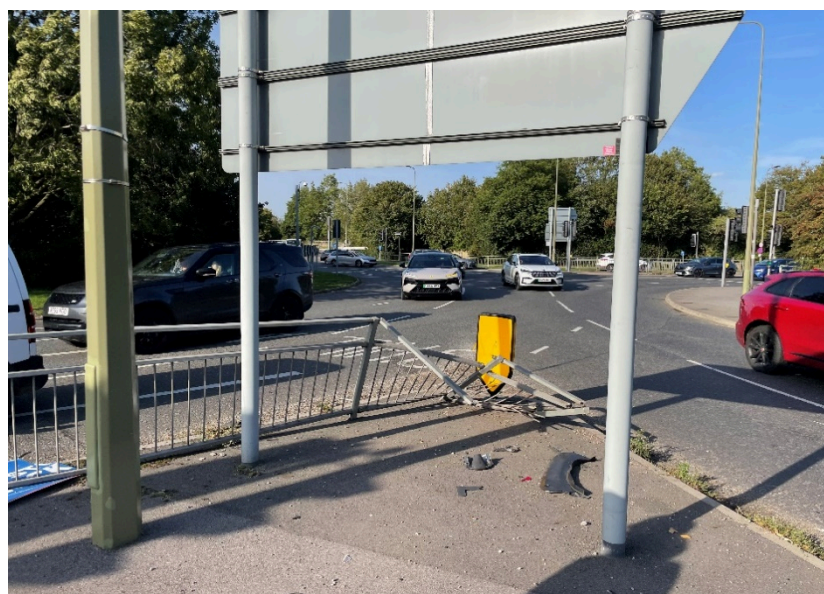
6) This accident involved a car and a bus. The bus was positioned in the lane heading to the left of the photo heading into Graven Hill. The car was heading towards Aylesbury and attempted to exit the roundabout in the lane to the right of the red car. Due to the lines taken and lanes allowing traffic to either head towards Graven Hill or Aylesbury on the A41, the car may have thought the bus was also heading towards the A41 as the red car has done. Likely the car driver was just trying to get ahead of the bus though. The view shown is looking back at the roundabout.

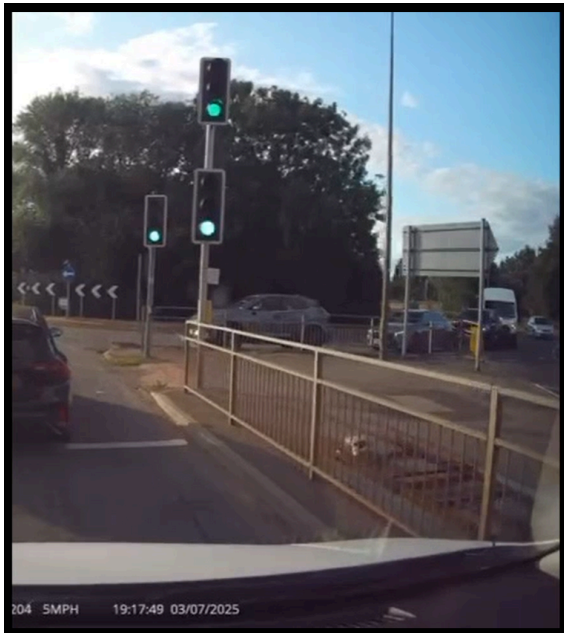
7) The following is dashcam footage showing an accident at the A41 eastern exit similar to that shown in 6). This time three vehicles heading towards Graven Hill are queued at the traffic lights when approached by a white van looking to head towards Aylesbury. As noted in the report provided to Councillor Gant, a second or third vehicle queuing here overhangs the exit and is vulnerable to traffic heading towards Aylesbury. This is exactly what happens here. The dashcam footage shows the white van hit the car, with that car being shunted into the one in front and that one similarly shunted into the one in front of that.

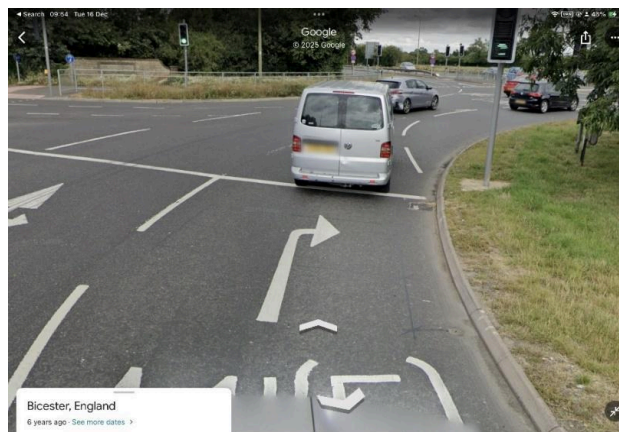
8) Not an incident, but a Google Maps view of the unnatural merge on the roundabout of the two lanes heading towards the Aylesbury on the A41 and Graven Hill. The vehicle below shown turning right onto Graven Hill is forced against the natural line to merge into a single central lane. This is often not apparent to any vehicle in the middle lane, which assumes that they are being cut up. This has been the cause of several incidents and near misses. It is also the cause of many horns being used as observed on the day of the visit and by Councillor Gant when he came to the roundabout.
