Safety of Rodney House Roundabout

This report has been prepared by Paul Davis, Chair, Graven Hill Residents' Association (GHRA), and a resident of Graven Hill for six years.

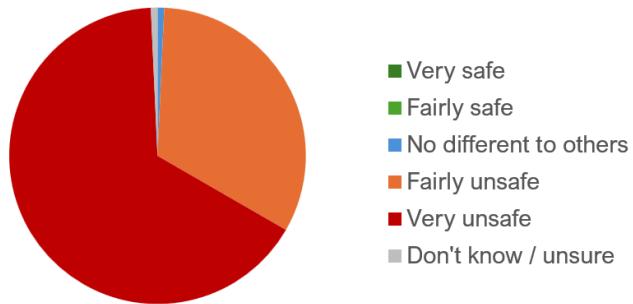
As a result of the issues with the roundabout, residents have serious concerns about its safety. A single-question poll demonstrated that not only did 99% of respondents believe the roundabout was unsafe, but that 64% believed it to be very unsafe. No-one chose the “fairly safe” or “very safe” options.

From your personal experience as a pedestrian, cyclist or driver using the official lane markings, how safe in your view is the Rodney House roundabout at the entrance to Graven Hill?
